Newsletter No. 8  
1348 Nonchalant Drive  
Simi Valley, California 93065  
29 January 1981

This newsletter is going to be a bit different. There is more material on trips people have taken and less on boat care details.

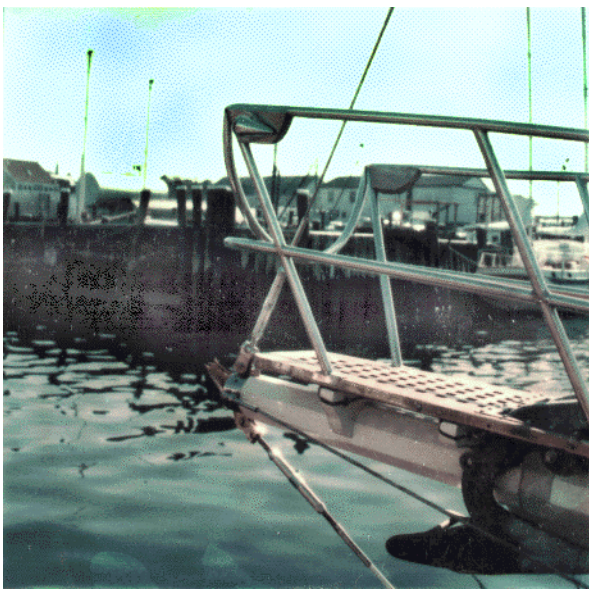
The photo shows the bent pulpit and if you look close, the missing bowsprit. I hope others will join me in a toast to the Clarks. By the way, the Clarks plan to try again in the early fall of '81. If any Tayana owners are interested in crewing with the Clarks please let me know. They will likely go down the east coast to Moorehead City before heading off the coast.

In the morning I went back to the boat and found the finger pier half gone, the bow sprit broken off up to the crane rim and the pulpit bent and twisted. Harmony had surged under the main pier when an 18 ton ketch in the outboard slip chuffed through some of her lines and crashed down on our finger pier. Two of the pilings were carried away and the walk way collapsed.

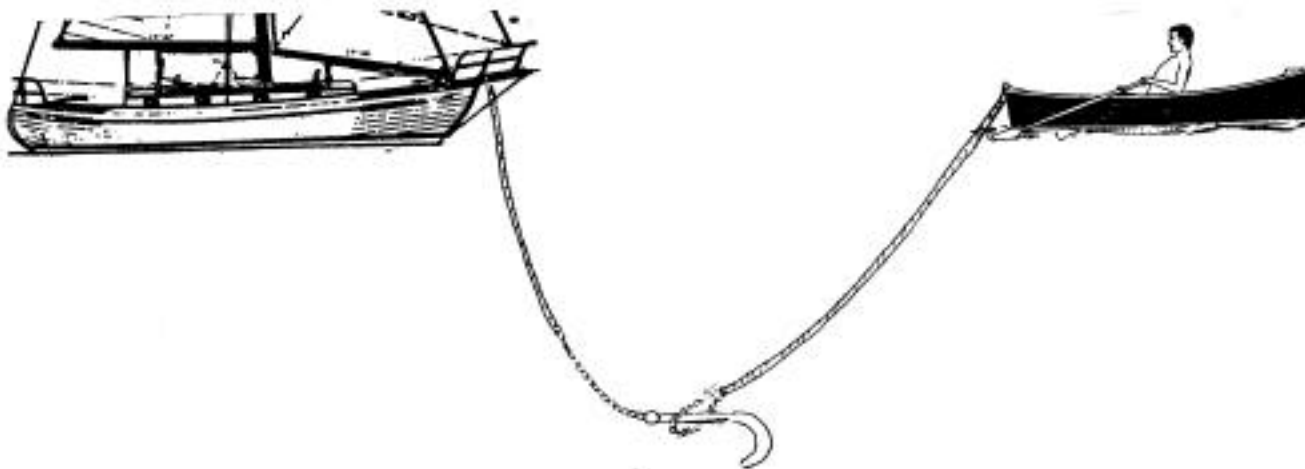
He made up a line with a short piece of chain attached. He makes a loop of the chain around the rode and rows his dinghy out beyond the fouled anchor pulling the line along the rode. He claims the chain will ride down to the anchor stock allowing it to be pulled free.

1. I recently took a weekend cruise to Santa Barbara Island, about 45 miles off the coast. I anchored in 35 ft. of water using my 45 lb. plow. When it came time to leave I could not break out the anchor. I circled around but it would not give. The bow pulpit vibrated badly each time the chain rode became taut. How I wished I had set the trip line but it's a nuisance. I finally donned Scuba gear and freed it. Later a friend of mine told me of a technique which he has used on fouled anchors.
