# THE TOG NEWS

A NEWSLETTER FOR TAYANA OWNERS

WINTER '87 NO. 37

Tayana Owners Group (TOG)  
Newsletter #37  
Winter 1987

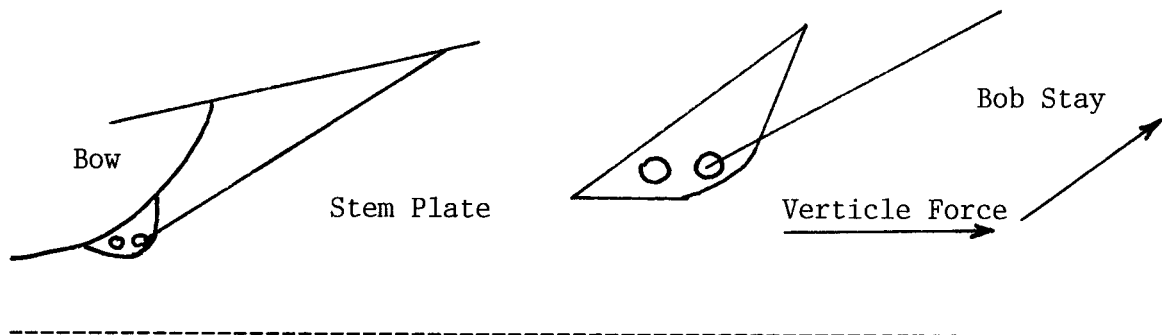
Ta-Yang Installed

In my opinion, agreed to by several other Tayana owners, Ta-Yang installs the bobstay fitting at the stem (waterline) upside down (or backwards depending how you look at it). The sketch below shows the "fix" for this situation." (Editors note - any comment on this from owners or dealers?)
